Chemo-Port Insertion in CA Stomach Patient

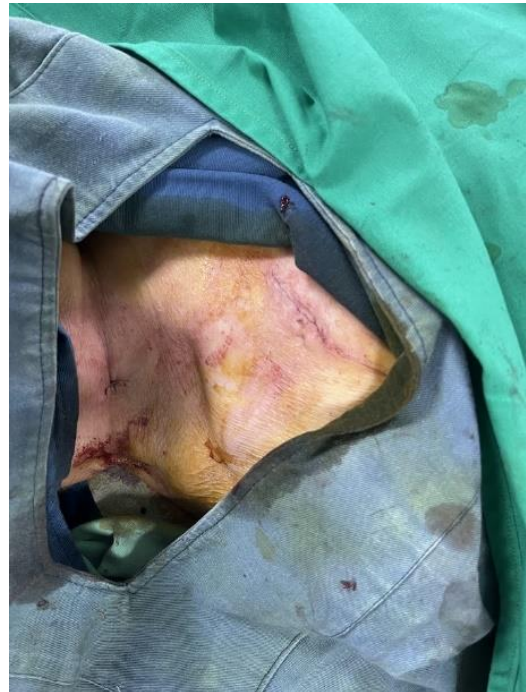
A separate incision of size approximately 3 cm was made on the chest wall at the level of 2nd rib. A subcutaneous pocket was made for chemo-port chamber, and catheter brought out in this wound with the help of a tunneller. The length of the catheter was measured at 0.5 cm below the sterno-manubrial joint. The catheter was attached with the chemo-port and checked the backflow. Heparinized saline was used to flush the port and catheter. The skin was sutured back. (Figure 2)

Figure (2) Post-op photo of chemo-port insertion

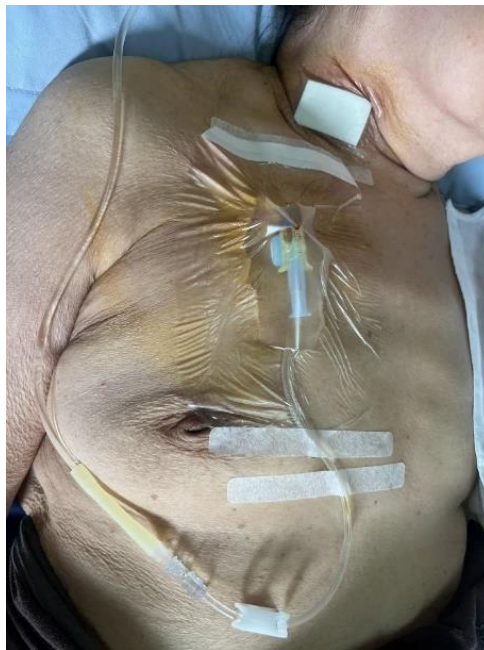
Huber's needle was put seven days after insertion. (Figure 3) Total parenteral nutrition and injections were given via the chemo-port.

Figure (3) Huber needle inserted

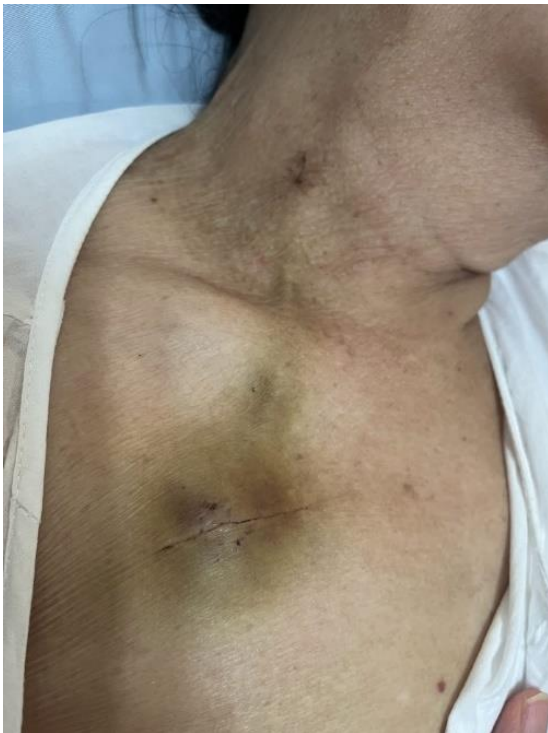
There were no serious complications in the post-op period. (Figure 4)

Figure (4) Post-op two weeks of chemo-port

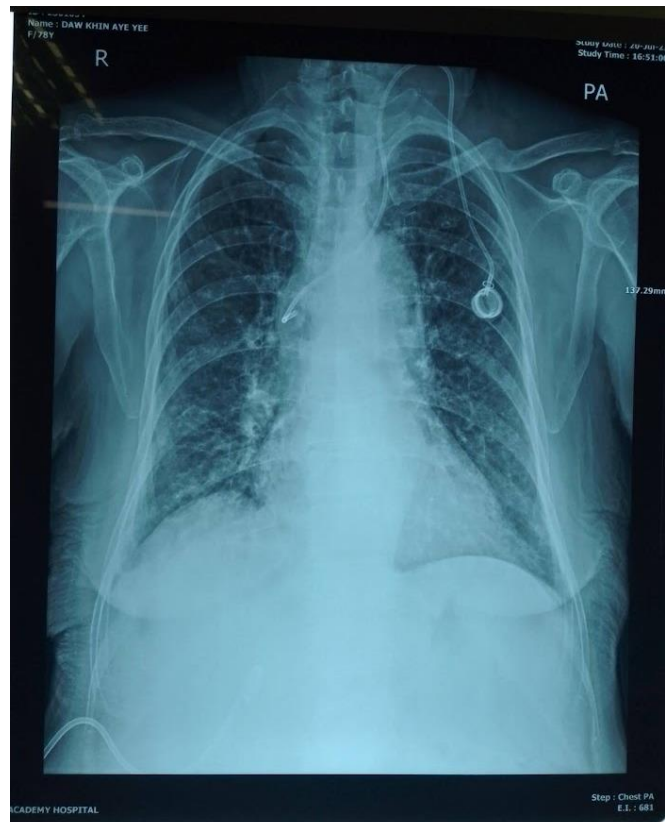
The patient received nutrition via the chemo-port and her well-being improved. One month later she accidentally injured the site of chemo-port and haematoma occurred. The chemo-port needed removal and another chemo-port was inserted on left side. (Figure 5)

Figure (5) Chemo-port inserted on left side

Another chemo-port was inserted on left side and the old one was removed. (Figure 5)
