Case Report

Journal of MAR Orthopedics (Volume 3 Issue 2)

The “Iliopsoas Polish” Resulting from Iliopsoas Impingement Against the Acetabular Component after Primary Total Hip Arthroplasty

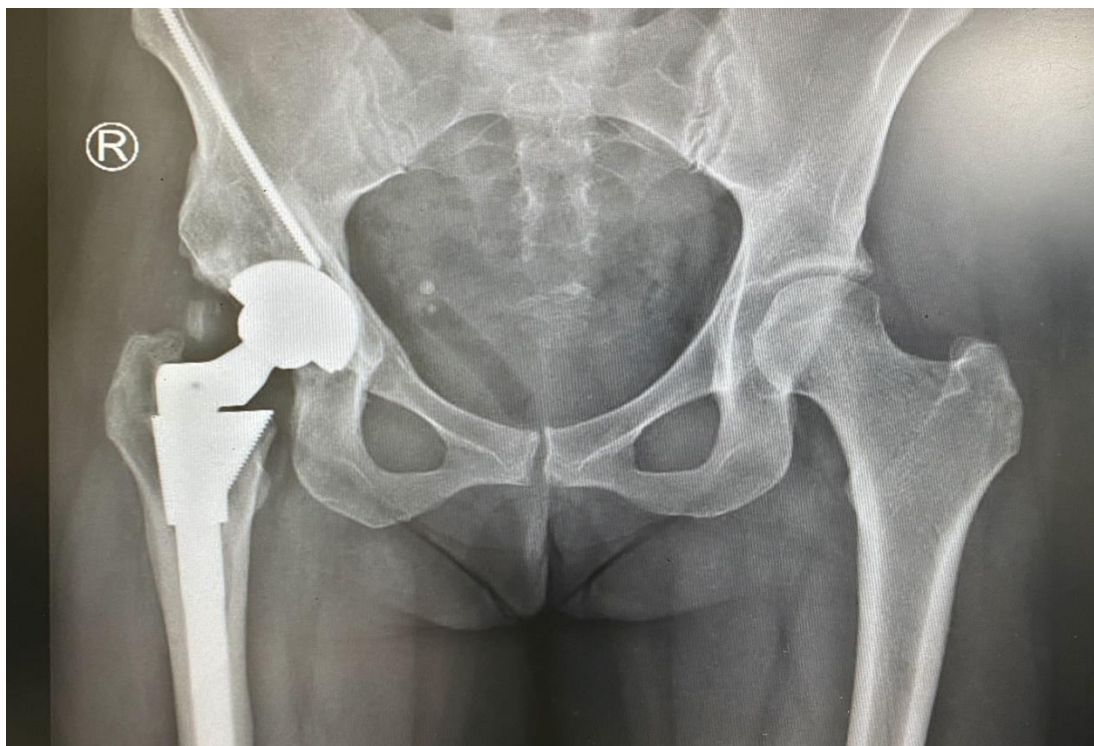
Figure 01- Plain Radiograph of the Pelvis taken at presentation

On presentation, she had an antalgic gait. She was using crutches. Her hip range of movements were very painful especially flexion and internal rotation. Resisted straight leg raise was also very painful. Plain radiographs of the pelvic (figure1) and a lateral (figure2) of the affected hip were undertaken. The lateral view showed that there was uncoverage of the acetabular component anteroinferiorly. A Computerised Tomography (CT) scan confirmed this (figure3). After discussion of options, the patient decided to proceed with revision of the acetabular component. Revision of the right THA was undertaken. A Standard Posterior approach using the previous incision scar was utilised. The Hip was dislocated and the ceramic head was removed. The trunnion of the femoral component was protected with a swab. The Acetabular component was then removed using the Explant system (Explant Acetabular Cup Removal System. Surgical Technique. Zimmer Inc., Swindon, UK.). The removed acetabular component showed complete loss of surface coating over the exposed area (Figure-4). The rest of the surface of the acetabular component showed no loss of surface coating with evidence of bone ingrowth on it (Figures 5,6). The Iliopsoas muscle was assessed and found to be thickened, possibly as a result of repeated impingement.

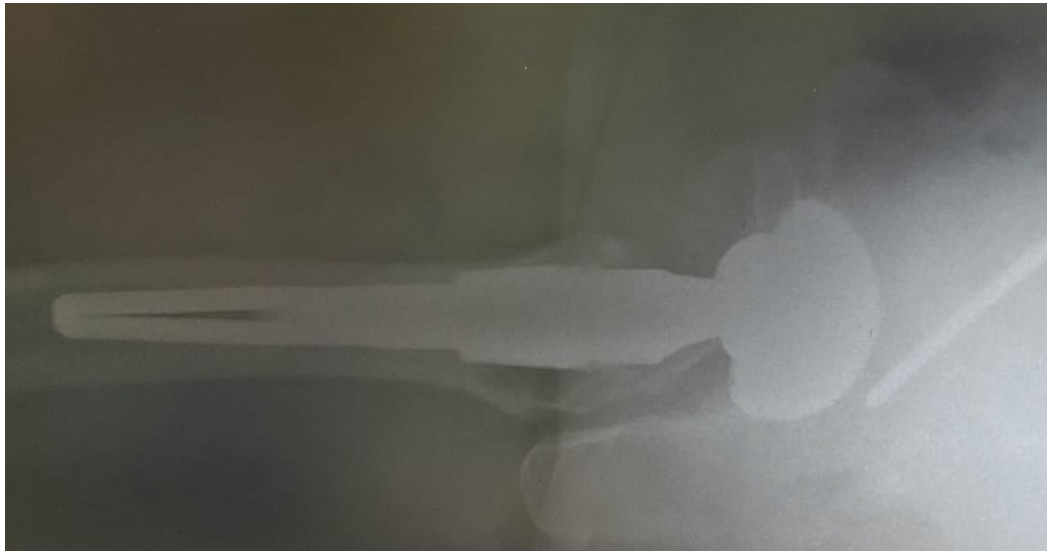
Figure 2- Lateral – Shoot through view of the same hip at presentation

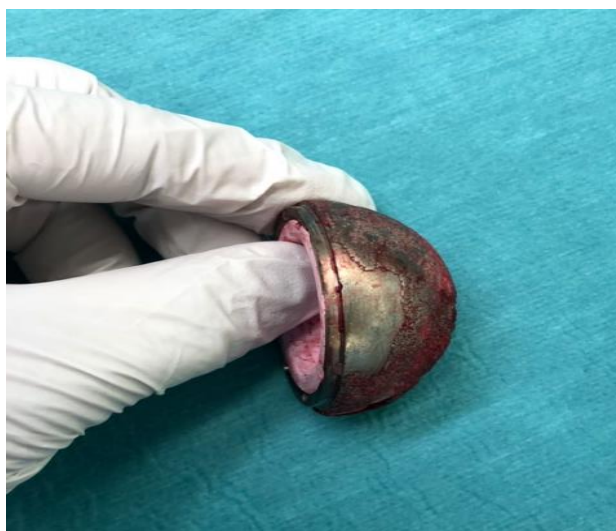
Figure 4. Removed Acetabular Component showing complete loss of surface coating over the exposed area.

Our case illustrates what the iliopsoas muscle can do to exposed surfaces of acetabular components. The iliopsoas in this case polished the surface coating off over the years it was exposed to. This indeed can lead to disabling pain. To our knowledge it is first time that we have shown evidence to this effect and the importance of the PF as against the TAL for optimum acetabular component positioning to prevent groin pain.

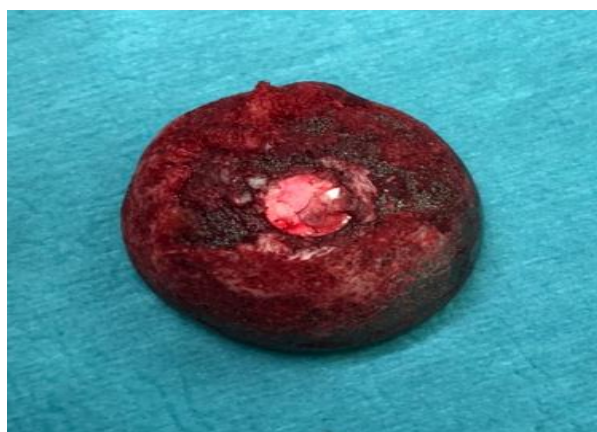
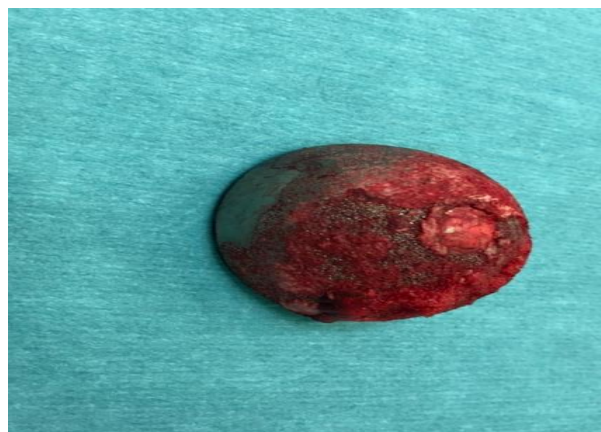
Figures 5,6- Removed Acetabular component showing presence of surface coating with evidence of bone in growth over the rest of the surface.

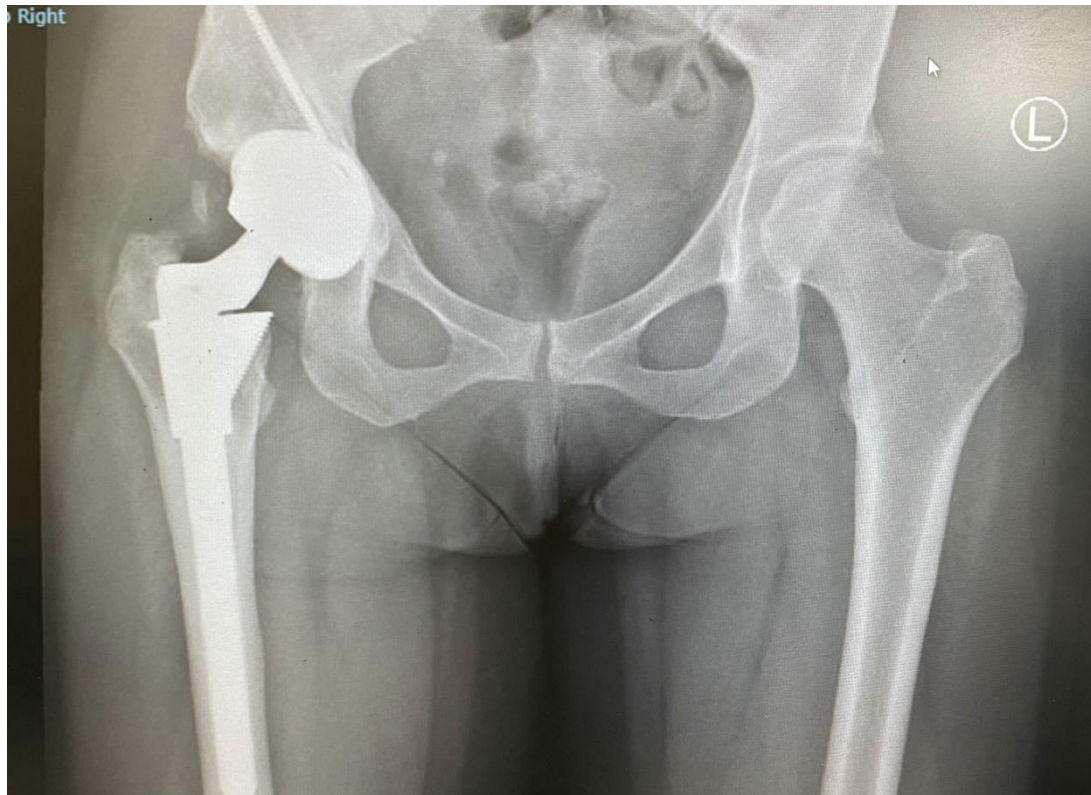
Figure 7- Plain Radiograph of the Pelvis at a Year postoperatively.

After reaming, a new Acetabular Component was inserted using the PF as the guide rather than the TAL. A 36mm Ceramic liner was then inserted. A new 36mm ceramic femoral head with a Bioball® adapter (Bioball®Merete GmbH, Berlin, Germany) was then inserted on the retained femoral component and the hip was reduced. Post-operatively she had immediate relief of pain. She was discharge day 1 postoperatively and made an excellent recovery. She is now 3 years since the revision procedure and remains symptom free. The postoperative radiographs taken at a year remain satisfactory (figures 7,8). The lateral view shows a broken drill bit which happened while drilling to create a passage for reattachment of the short external rotators of the hip. This to date has not caused any problems (figure8)
